Public Utilities Commission of the City of Sault Ste. Marie

Drinking Water System Asset Management Plan

Technical Memo – Lifecycle Strategy and Financial Planning

Date: July 2023

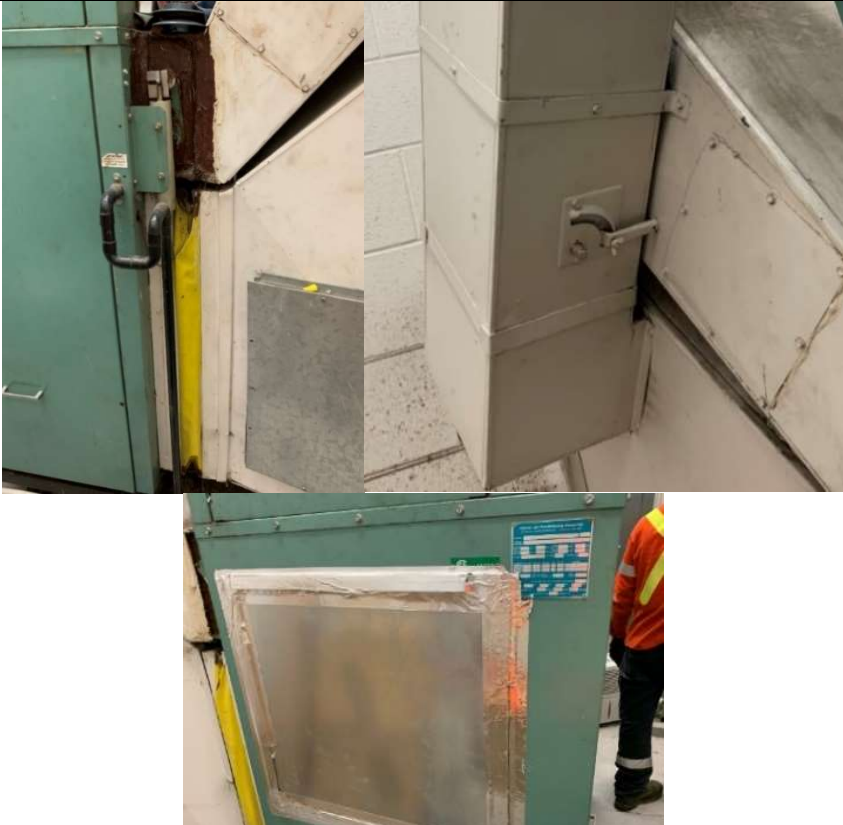
Direction Photo Taken WTP - AHU2		
Description Patches and possible leak locations

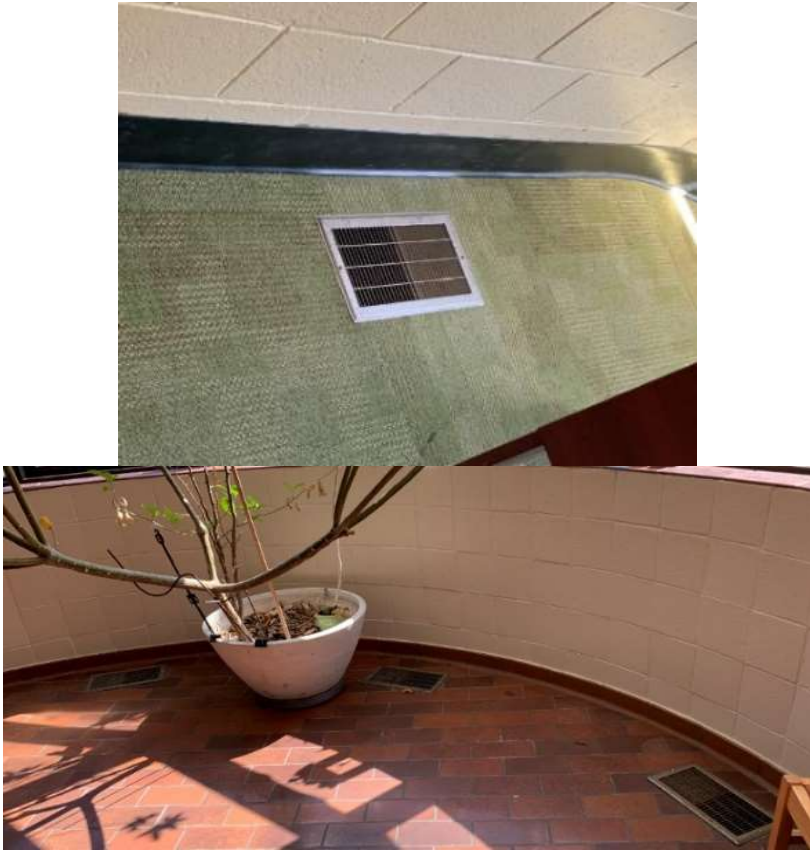
Direction Photo Taken WTP - Control Room & Staff Room		
Description In-floor electric heaters
