Public Utilities Commission of the City of Sault Ste. Marie

Drinking Water System Asset Management Plan

Technical Memo – Lifecycle Strategy and Financial Planning

Date: July 2023

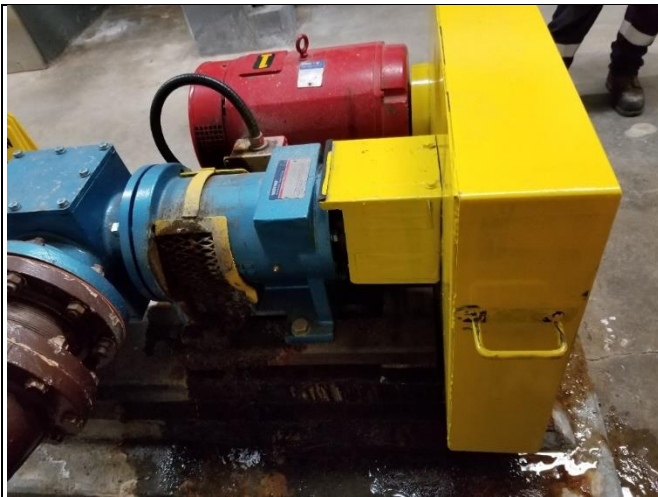
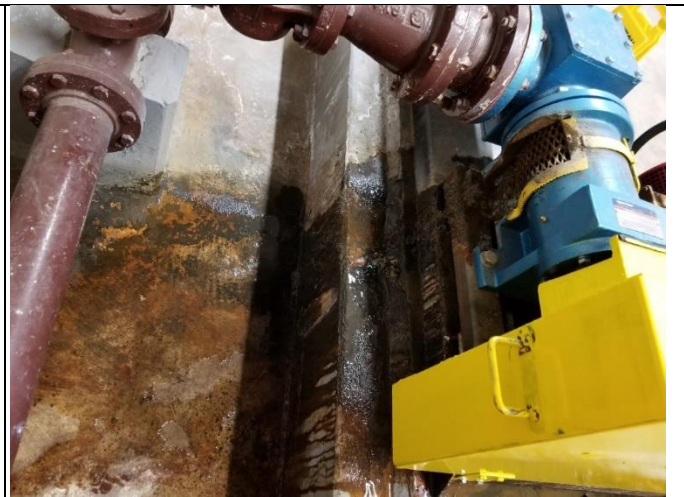
Unique ID	Asset Description	Level 3 – Process Location	Level 4 – Asset Category	Level 5 (Asset Type)	Install Year	Condition Comments	PUC Staff Comments Summary
300000188	Pump, sludge pump 1	Pipe Gallery (Basement)	Process Mechanical	Pump	1986	Seal is worn and causes leaking evident on pump base and water pooling on floor. Deterioration evident.	Not performing at designed flow rate.

Pump, sludge pump 1 (Score: 5-Very Poor)

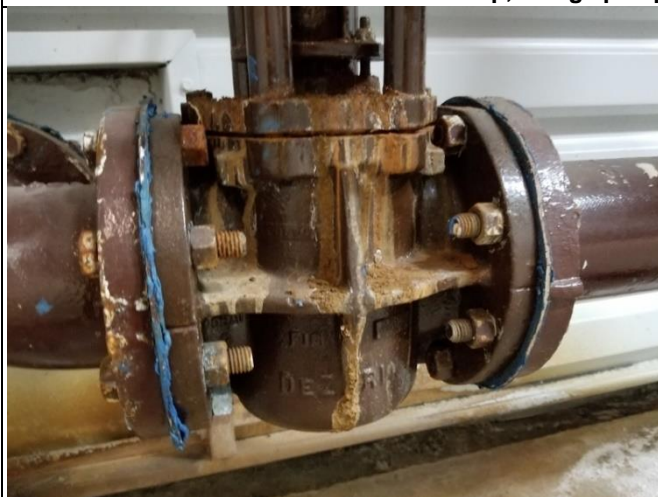
Valve plug, suction sludge pump BW Tank No. 2 (Score: 4-Poor)

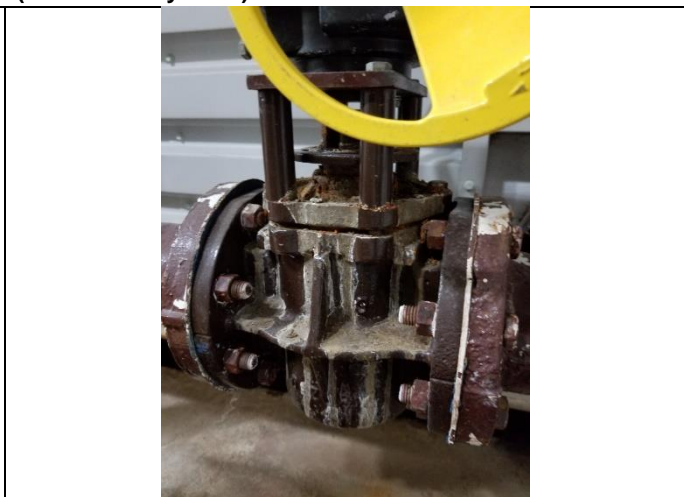
Valve plug, suction sludge pump BW Tank No. 1 (Score: 4-Poor)

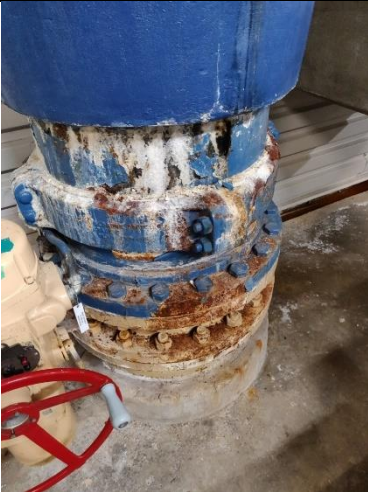
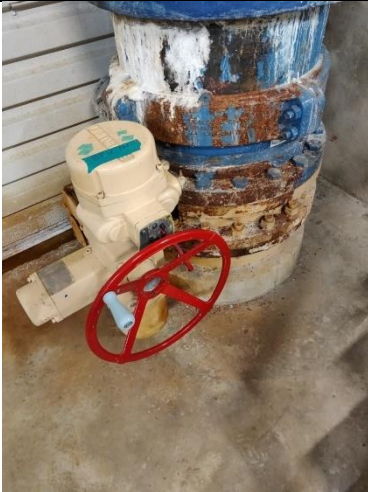
<p>Valve Butterfly Filter 1 Drain (Score: 4-Poor)</p>		<p>Valve Butterfly Filter 2 Drain (Score: 4-Poor)</p>

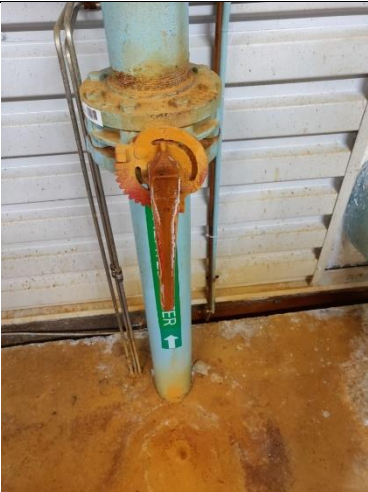
<p>Valve Butterfly Filter 4 Surface Wash (Score: 4-Poor)</p>

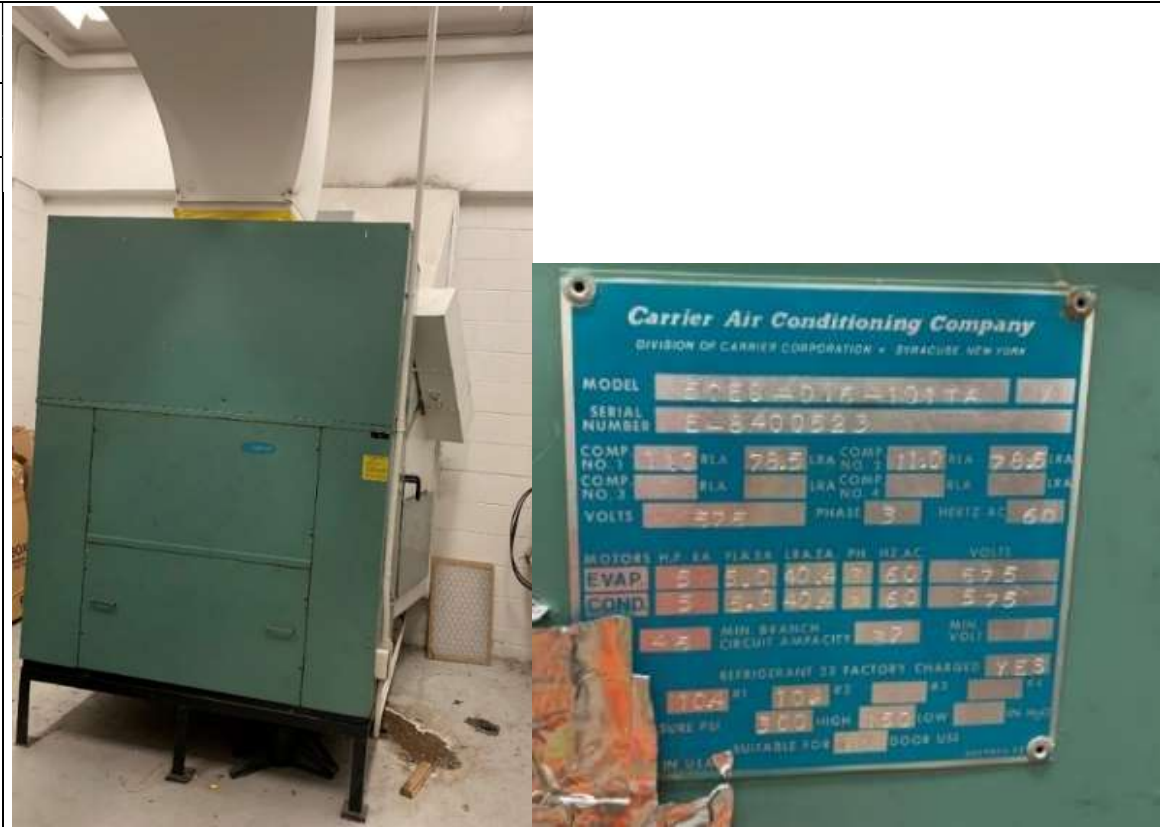
Photo No. M2	Date 9/1/2020
Direction Photo Taken WTP - AHU2	
Description AHU-2 and its nameplate

The existing Carrier 50EC-016-101TA packaged unit (AHU-2), Photo M2, has exceeded its estimated service life expectancy and utilizes R22 (HCFC) refrigerant. HCFC refrigerants have been phased out and are no longer commercially available, including HCFC equipment. It is our opinion that this unit should be replaced.

- AHU-2, along with its components, need to be replaced.
- Include humidifier and dehumidifier modules in the AHU-2.
- All ductwork, duct insulation, etc. are recommended to be replaced.
- Add centralized Building Automation System (BAS).
- Convert AHU-2 to a natural gas-fired unit with more energy-efficient options.
- Change the heating system to natural gas-fired. Existing electric heating coil and electric heaters may remain for redundancy.
- Extend AHU-2 return air closer to the office area or use ducted return.
- Use demand based ventilation based on indoor air quality.
- Infiltration needs to be reduced, and all the leaks from the building or the ducts need to be stopped.
- Control humidity in the control room throughout the year.

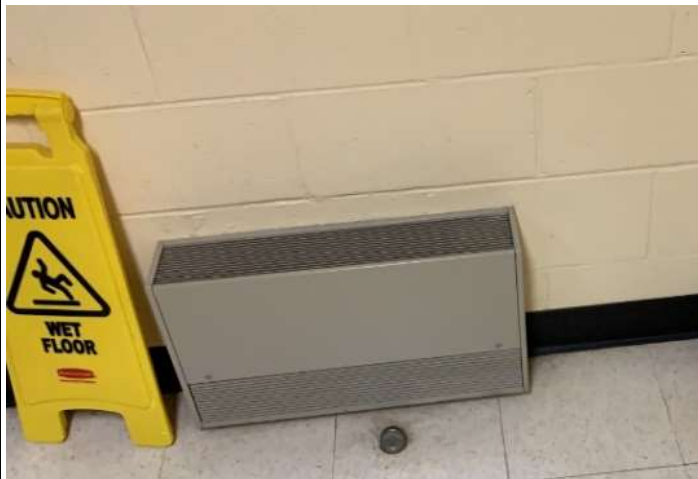
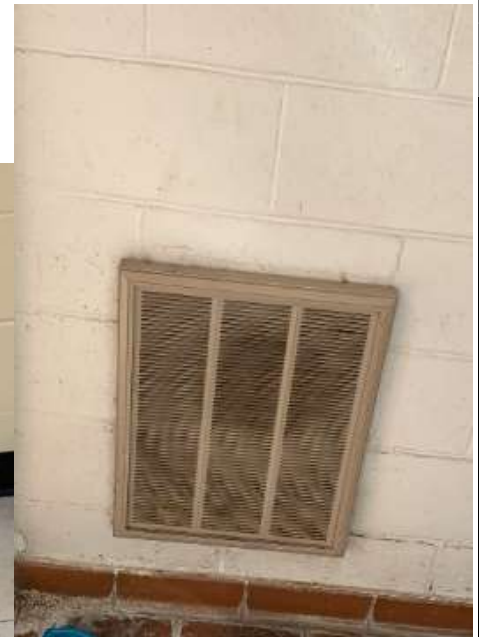
Photo No. M8	Date 9/1/2020
Direction Photo Taken WTP - WC and Entrance	
Description Electric cabinet heaters and electric force flow heaters

Space heating is provided utilizing a combination of floor-mounted electric cabinet heaters and semi-recessed electric force flow heaters, located throughout the office area. They appear to be in moderate visible condition. Photo M8.

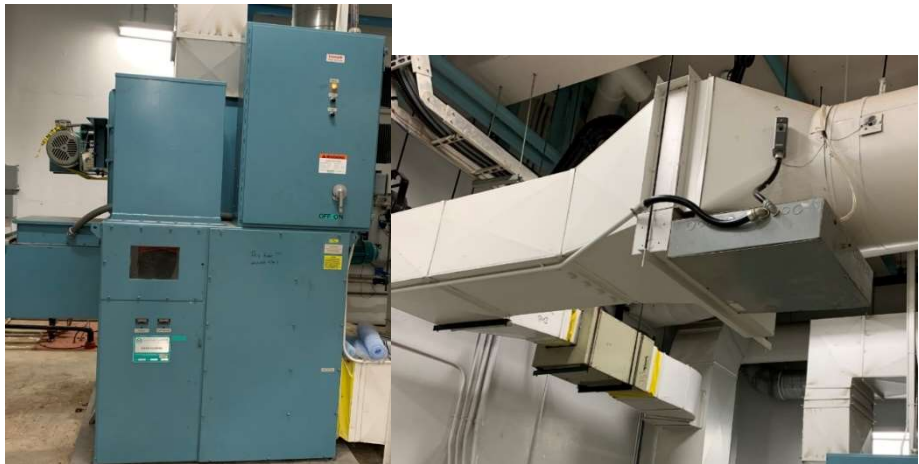
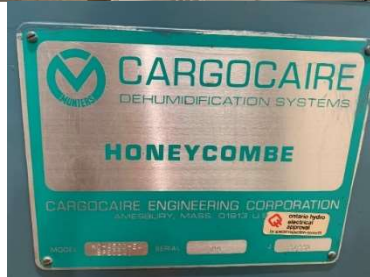
Photo No. M12	Date 9/1/2020
Direction Photo Taken WTP - AHU1	
Description AHU-1 dehumidifier, its name plate and ducted type reactivation filter/ electric heater

This unit is connected to a commercial type dehumidifier unit, Photo M12.

The dehumidifier's make and model are CargoCaire Honeycombe Model HC-4500-EA Special. It is equipped with a ducted type inline reactivation electric heater and a ducted filter. The reactivation air is discharged to the outdoors through the roof.

- AHU-1, along with its components, needs to be removed and replaced with more efficient heat recovery options.
- Convert the reactivation heater module to a natural gas-fired type.
- Ductwork, duct insulation, etc. are recommended to be replaced.
- Add centralized Building Automation System-BAS.
- Change the heating system to natural gas fired. Existing electric heating coil and electric heaters may be maintained for redundancy.
- A more stable, consistent and closed-loop cooling system design is recommended. Separate cooling system from the drinking water system and avoid contamination or any backflow.
- Separate diesel pump combustion and cooling air from the ambient air.
- Use variable ventilation air based on indoor air quality.
- Infiltration and duct leakage need to be reduced to acceptable values.
- Humidity levels need to be monitored and controlled throughout the year.

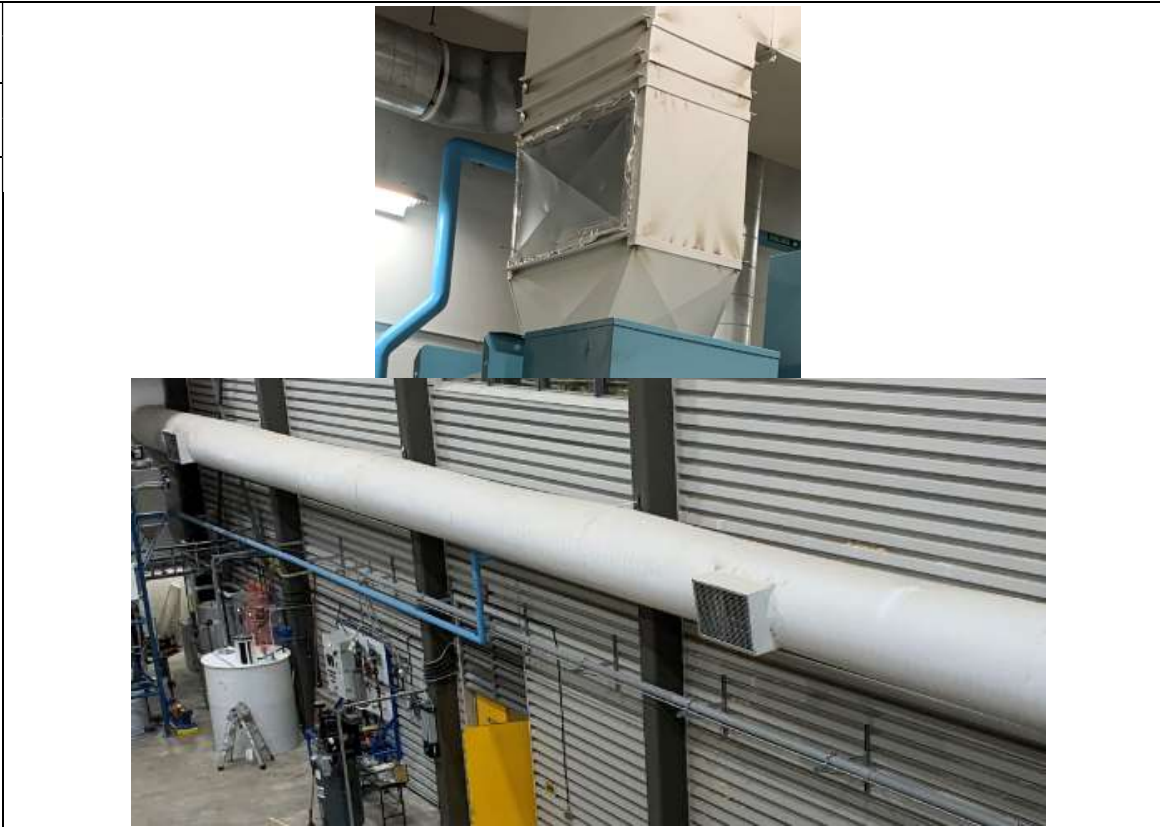
Photo No.: M14	Date: 9/1/2020
Direction Photo Taken: WTP-AHU1&High Lift S.	
Description: Duct patch at the dehumidifier inlet and round supply ducts in the High Lift Station

Both supply and return ducts are uninsulated round ducts except in the crawl space section. The only insulated duct is the supply duct in the crawl space, which is aluminum foiled fiberglass insulation without any insulation jacketing. The ducts were in moderate condition, with the exception of some patches and leakage observed, Photo M14.

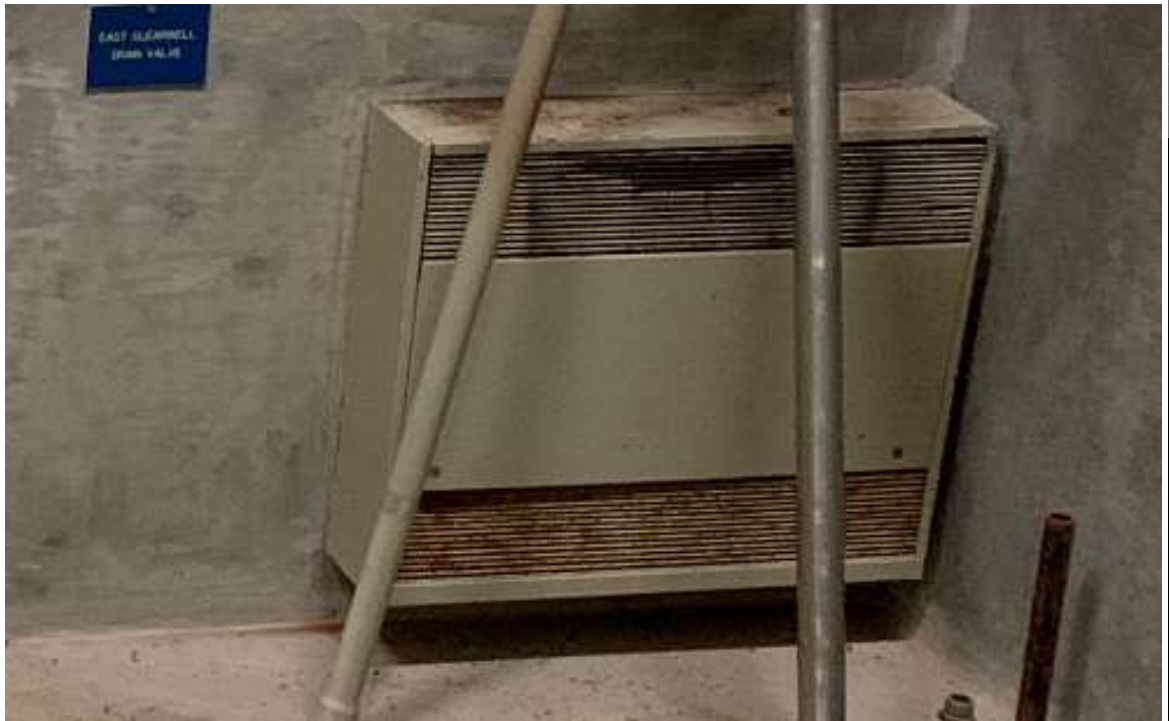
Photo No. M17	Date 9/1/2020
Direction Photo Taken WTP-Reservoir Access	
Description Cabinet electric heater

Space heating is provided by floor-mounted electric cabinet heaters. While they appear to be functional, most are corroded, old, and not reliable, Photo M17.

We observed that some of the cabinet heaters are running even though heating is not required. It is likely these heaters are not connected to a thermostat, or built-in thermostats are set incorrectly.

- All thermostats are recommended to be converted to energy-saving type.
- Connect all electric heaters to a thermostat if not already connected.
- All maintenance work needs to be done periodically and recorded.
- Clean and repair all existing cabinet heaters and force flow heaters.
- Replace corroded or dysfunctional electric cabinet heaters.
- Clean and repair all existing unit heaters.
- Repair or replace any leaking duct and worn-out insulation.
- Repair all missing or broken pipe insulation.
- Replace filters and clean strainers.
- Check all back-draft dampers, replace them if they are not operational.
- Check all fire dampers, replace them if necessary.

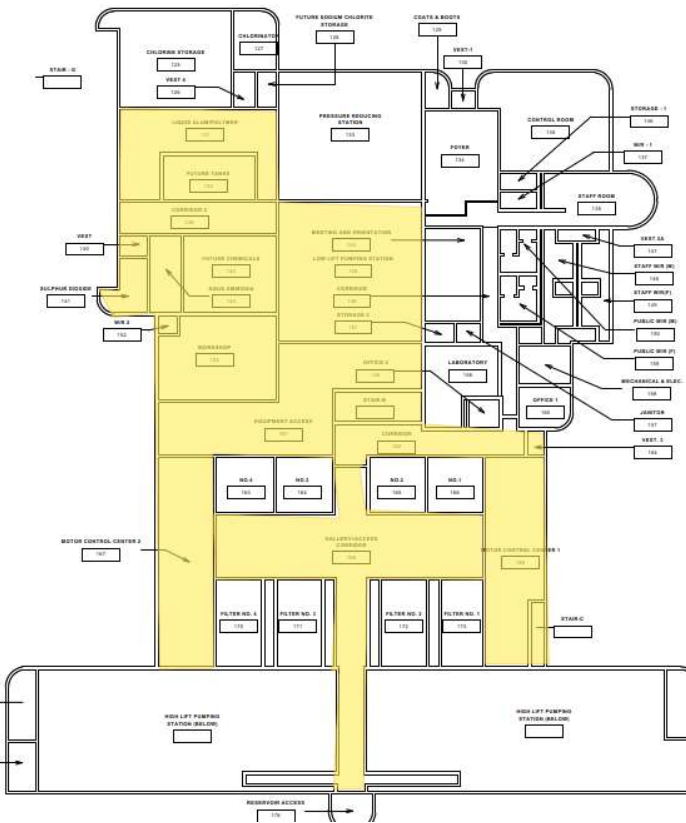
Photo No.: M20	Date: 9/1/2020
Direction Photo Taken: WTP- Ground Floor Plan	
Description: Ground floor mechanically unventilated areas

Mechanically unventilated areas on the ground floor are highlighted in yellow as per Figure M20. The majority of these areas include dedicated exhaust systems, either directly exhausted through the roof, or ducted exhaust to the side walls or the roof. No heat recovery was observed. Heated ambient air during the heating season is exhausted directly to the atmosphere.

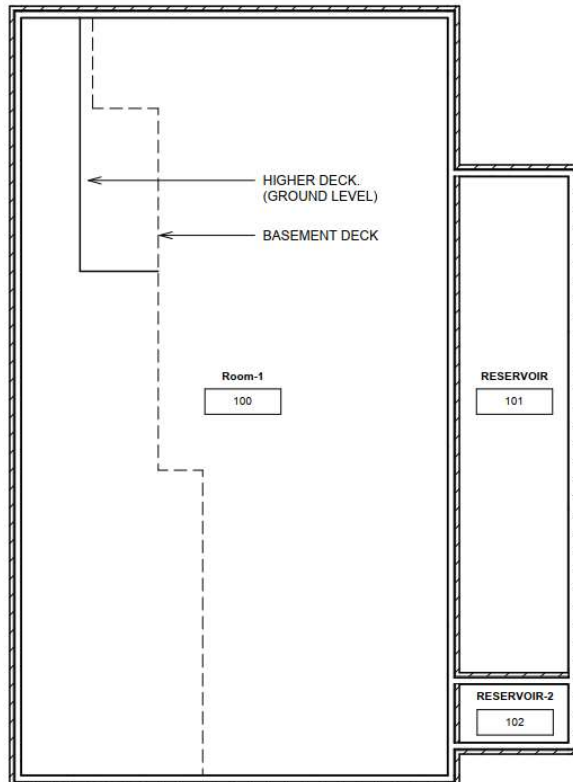
Photo No. M58	Date 9/2/2020
Direction Photo Taken PZ2 Booster Station	
Description Floor plan

The existing building was constructed in 1963, and the mechanical systems appear to be from the original construction, Figure M58. The building roof was scheduled to be replaced in 2020.

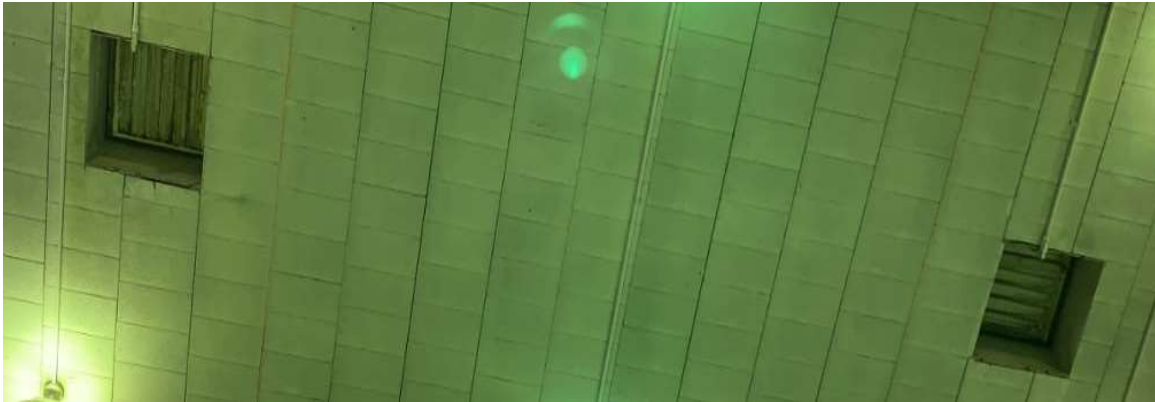
Photo No. M60	Date 9/2/2020

This station does not include a means of mechanical ventilation. Ventilation is being provided by infiltration. Two (2) roof exhaust fans with gravity dampers and manually opening windows were observed, Photo M60. We were unable to determine their condition or the manufacturing date, but they will be replaced with the roof this year, as reported by facility staff.

Direction Photo Taken PZ2 Booster Station		
Description Roof exhaust fans and gravity dampers

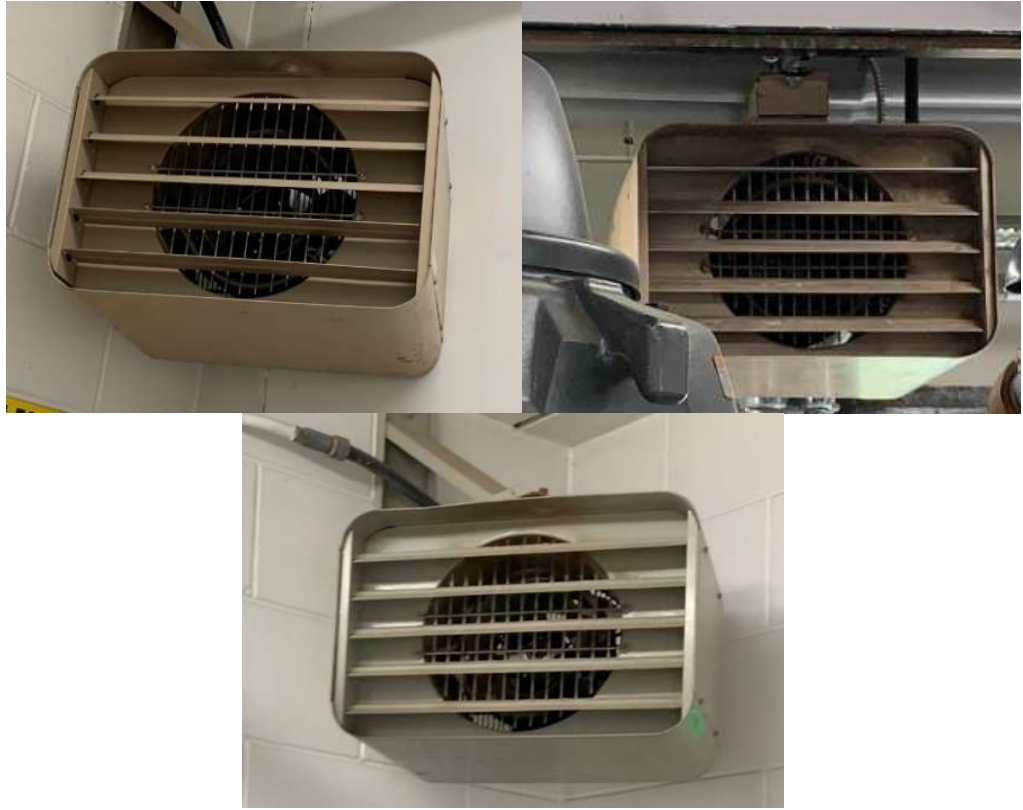
There is one (1) electric unit heater in the Blended Phosphate Room, one (1) in the Pump Room, and one (1) in the Chlorine Room. They are functional, but we were unable to determine their manufacture date. They appear to be installed later to replace the original heaters, Photo-M63.

Photo No. M63	Date 9/1/2020
Direction Photo Taken Goulias Well	
Description Blended Phosphate Room electric unit heater (top-left), Pump Room electric unit heater (top-right) and Chlorine Room electric unit heater (bottom)

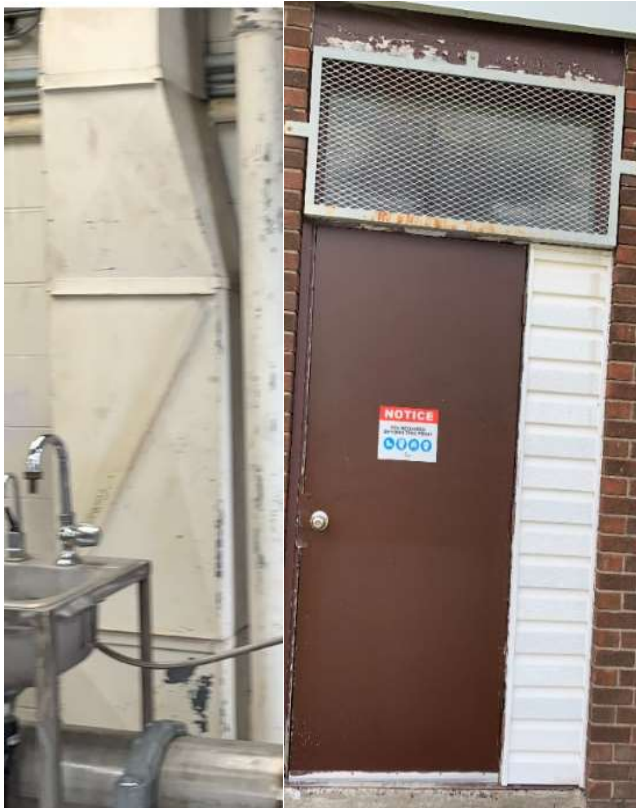
The Chlorine Room includes one (1) ducted type roof exhaust fan and one (1) large wall louver. This louver appears to have been replaced with a window, Photo M66. The roof exhaust fan was replaced in 2019 as reported by the facility staff.

Photo No. M66	Date 9/1/2020
Direction Photo Taken Goulias Well	
Description Chlorine Room roof exhaust fan duct connection (left) and original wall louver location (right)

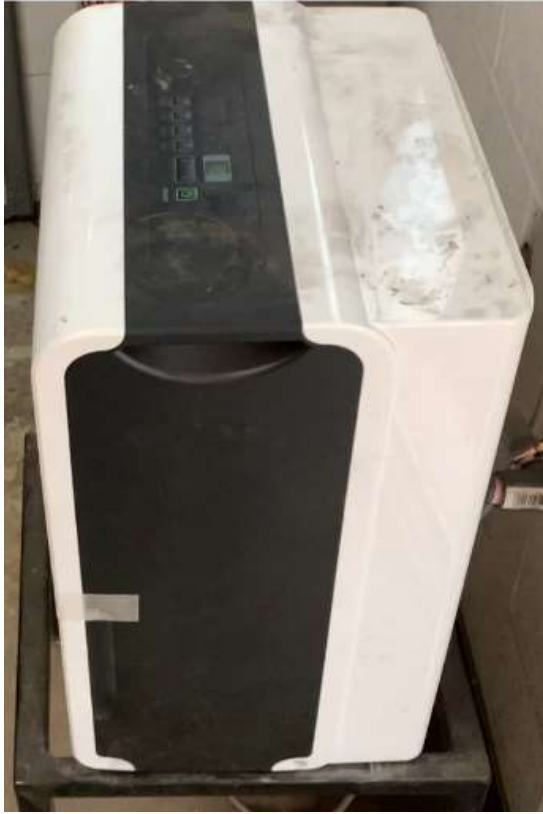
There is one (1) portable dehumidifier in the Chlorine Room to reduce relative humidity levels and the water-chlorine interaction. The portable dehumidifiers generally do not last long; they are replaced every one or two years, as reported by the facility staff, Photo M67.

Photo No. M67	Date 9/1/2020
Direction Photo Taken Goulias Well	
Description Chlorine Room portable dehumidifier

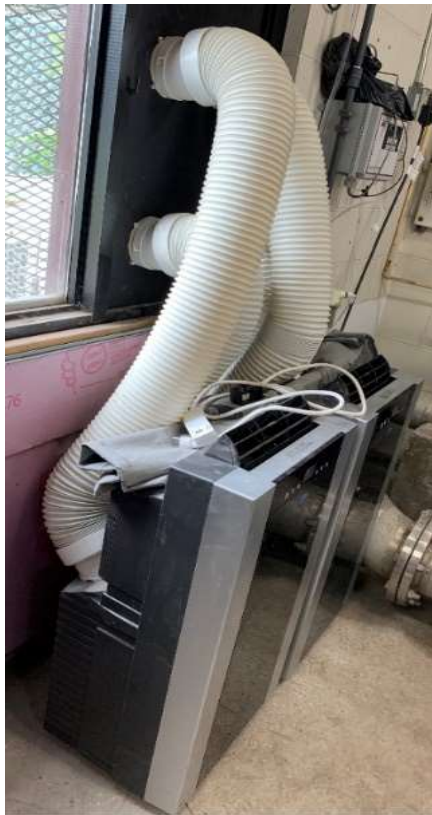
The Pump Room includes two (2) portable air conditioning (AC) units, Photo M68. These units also do not last that long, and need to be replaced every year or two, as reported by facility staff. The main heat sources are the main vertical turbine motor, the variable frequency drive (VFD), and its harmonic filter. The heat gain from this equipment generates results in elevated ambient conditions in the cooling season and requires air conditioning.

Photo No. M68	Date 9/1/2020
Direction Photo Taken Goulias Well	
Description Pump Room portable air conditioning units

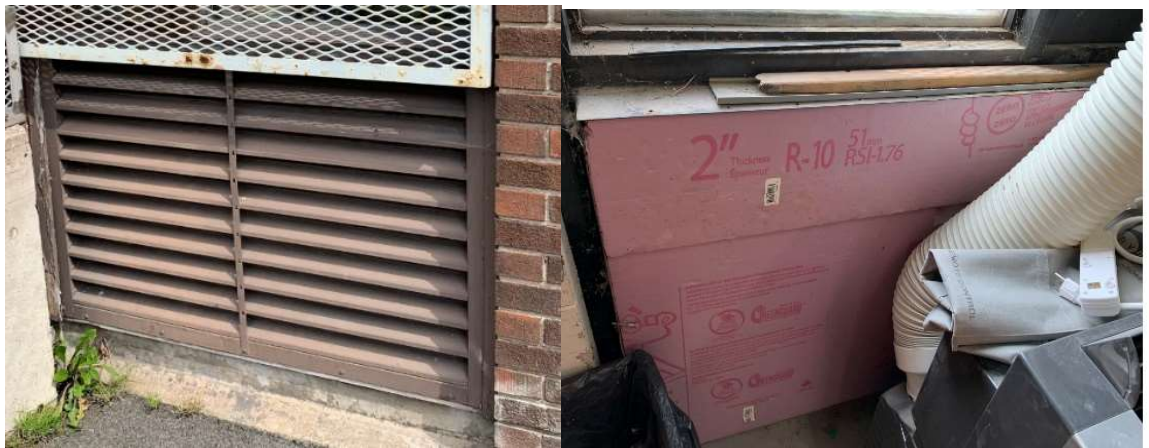
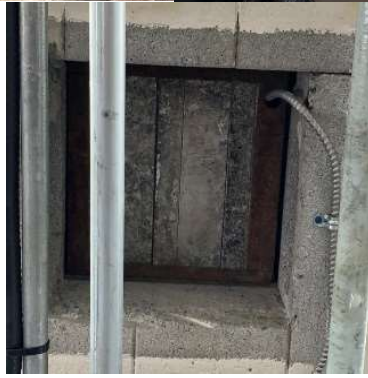
There are is a roof exhaust fan and large wall louver. The roof exhaust fan was replaced in 2019 as reported by the facility staff. The wall louver is capped, Photo M69.

Photo No. M69	Date 9/1/2020
Direction Photo Taken Goulias Well	
Description Pump Room wall louver (taken from outside – top-left, taken from inside – top-right) and roof exhaust fan with gravity damper (bottom)
